Uplyme

Key Flood Risk Areas:

Uplyme Flood Incident 7th July 2012

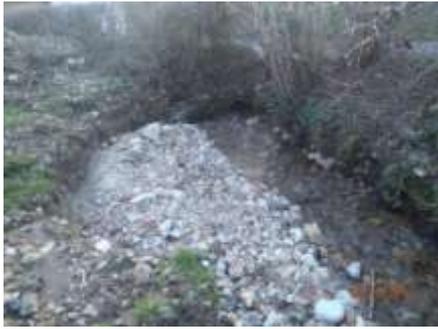
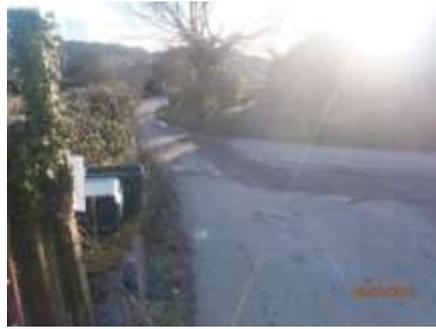
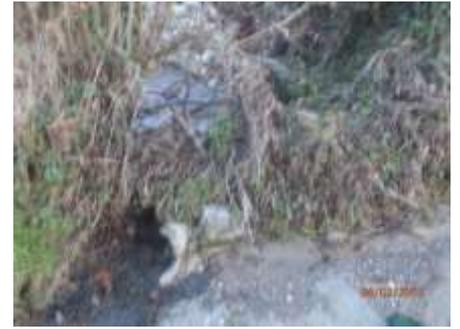
The watercourse from direction of Valley View Farm which is culverted under Lime Kiln Lane and Cooksmead becomes rapidly blocked with shingle/gravel/silt debris. Upstream a large 'goyle' has formed which has the potential to increase silt loading within the watercourse at this location. The culvert surcharges and floods/deposit materials onto the highway, this flood water was responsible for the flooding of properties within Cooksmead and the bottom of Pound Lane. This watercourse runs behind the Post Office and the local filling station and responsible for flooding at this location. The watercourse then enters two stone cross culverts under the B3165 outside the Village hall and at the bottom of the Village hall car park discharging into the River Lyme downstream of the B3165 bridge. The cross culvert running from the filling station to the village hall surcharge causing flooding of the B3165. Informal grips are cut into the verge adjacent to the Village hall car park to allow flood water to re-enter the channel (which reaches bank fall) and prevent properties adjacent to the highway flooding. The culvert at the bottom of the Village Hall car park surcharged and causes flooding to the Tennis Courts and the cricket fields. The flooding at Venlake was caused by the watercourse adjacent to PROW (footpath), which is then culverted under the highway via a 600mm dia. pipe discharging into a ditch adjacent to the highway. The flooding which occurred at this location was a combination of events, the culvert had insufficient capacity to take the flow conditions at the time and surcharged onto the highway, also a collapse of the riparian banks along the watercourse caused significant flooding to a property adjacent to the watercourse and the footpath.

600 mm passing under Lime Kiln Lane/Pounds Lane into ditchcourse running adjacent to No.1 Cooks Mead. Large accumulation of gravel blocking culvert entrance particularly during high flows. Informal silt trap constructed within channel but difficulties gaining access to clear. Formal silt trap could be constructed at this location however culvert immediately upstream suffers blockage and flows onto highway

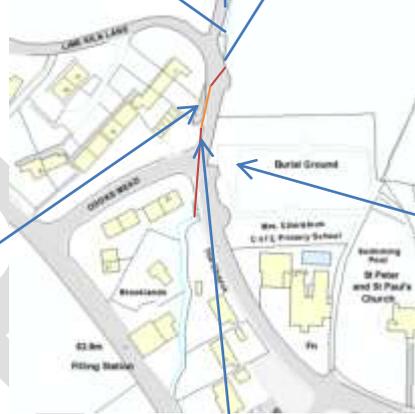
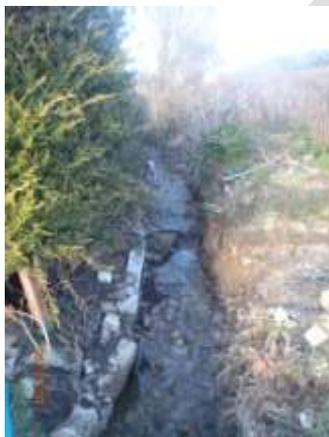
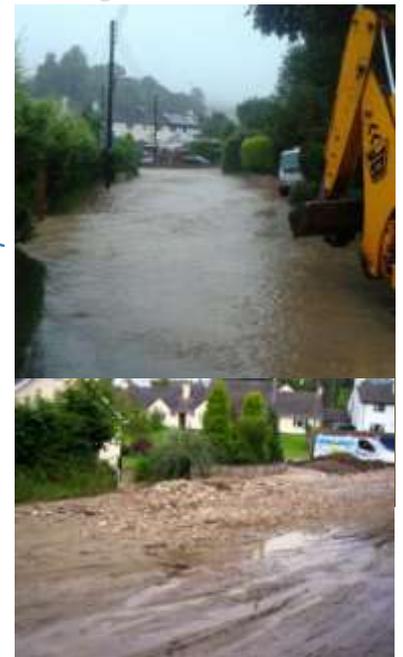
Once culvert is blockage flows are diverted onto the highway causing flooding to properties on Cooksmead/Pound Lane. Deposition of material onto the highway. DCC Highways continues to clear up debris which is extensive and follow up jetting to highway gullies in area. Now a regular occurrence in time of storm conditions. Road becomes impassable.

Ditchcourse running adjacent to No.1 Cooks Mead flowing to 450/600 mm culvert passing under Cooksmead into Brooklands. Large accumulation of gravel blocking culvert entrance particularly during high flows. Culvert quickly surcharges and flood waters onto the highway.

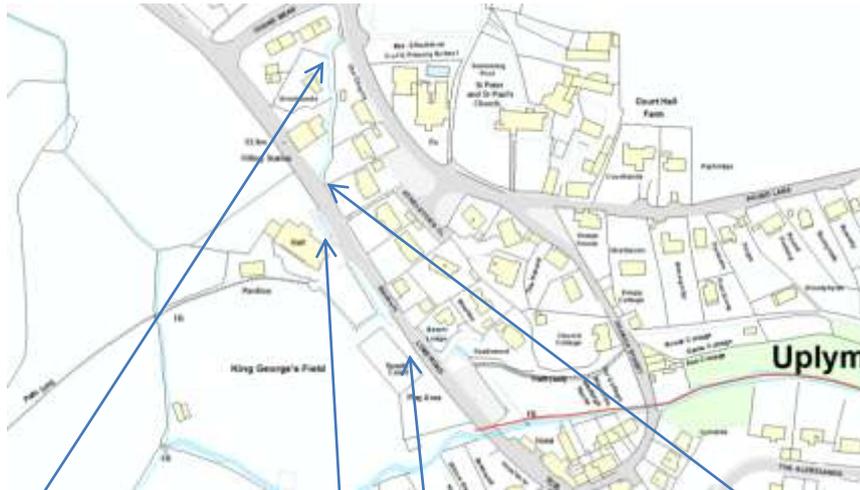
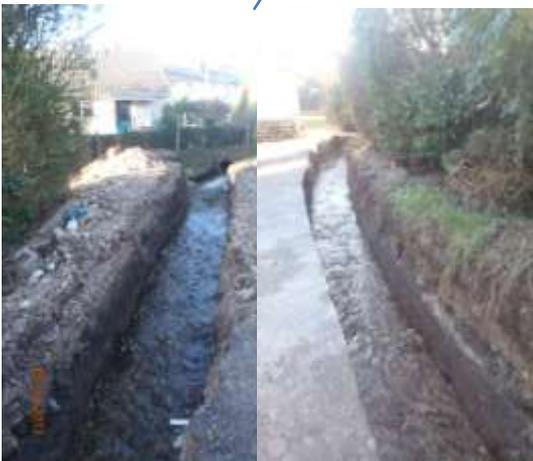
Flooding to the rear of Brooklands resulting from channel behind property being overwhelmed when flows are backed up from highway culvert. Flood relief channel has been constructed to convey flows around property in high flow conditions which is still to be completed.

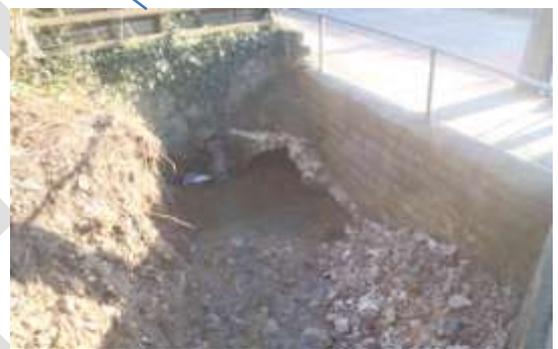
The cross culvert (masonry arch approximately 1mx0.5m) running from the filling station to the village hall surcharges causing flooding of the B3165. Becomes rapidly blocked with shingle/gravel/silt debris and potential for silt trap at this location. Grips were then cut into the verge adjacent to the Village hall car park to allow flood water to re-enter the channel (which was bank fall) and prevent properties adjacent to the highway flooding

Cable crossing downstream of the first culvert crossing of the B3165 outside Uplym Village Hall. Installed during the construction of the Village Hall. During high flows acts as a weir raising levels potentially to height of upstream culvert. Silting up reducing flow results in the channel overtopping and flooding to village hall.

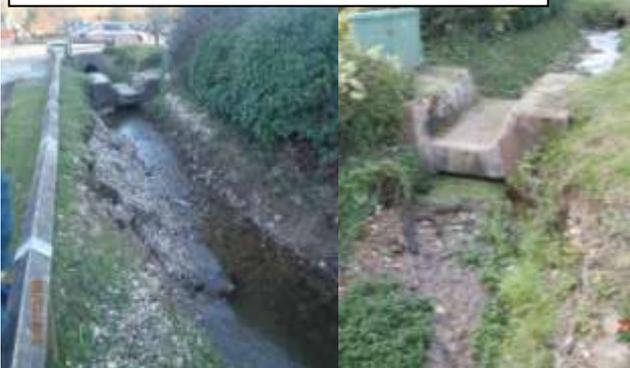
Masonry culvert downstream of Village Hall (approximately 1mx0.5m - potentially problems with channel gradient) quickly surcharges raising water levels within the channel and floods the Tennis Courts. Culvert turns right angles due to the realignment of the channel. DCC Highways continue to carry out reactive machine clearance to inlet/outlets of culverts followed by jetting to remove silt/debris from invert. Informal flood channel created to allow flood waters when surcharging to flow into Tennis courts (photos below). Potential for permanent flood relief channel to be constructed at this location to convey flows directly to the River Lyn upstream of the road bridge.

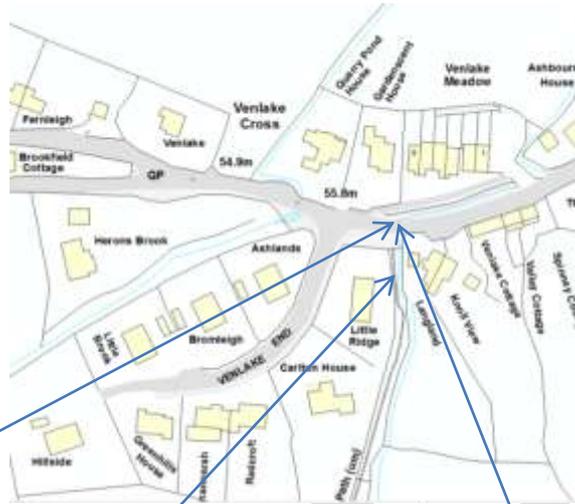
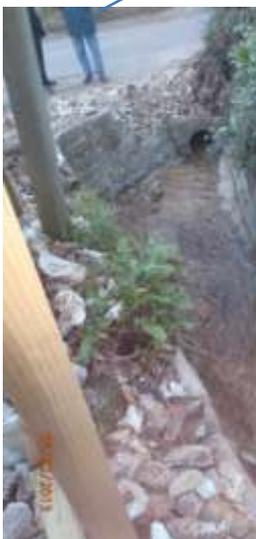
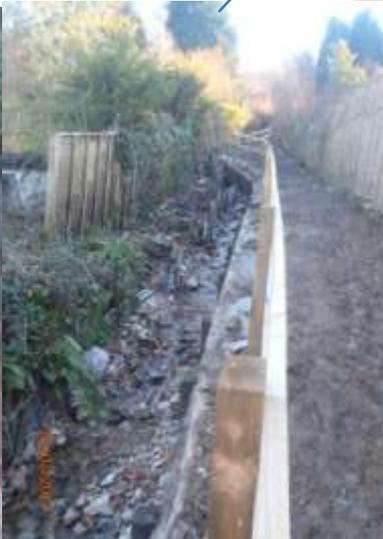
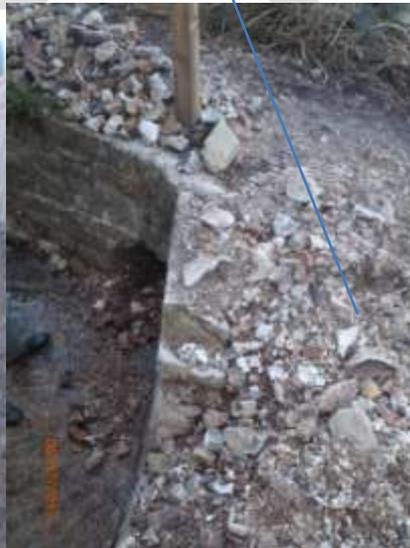
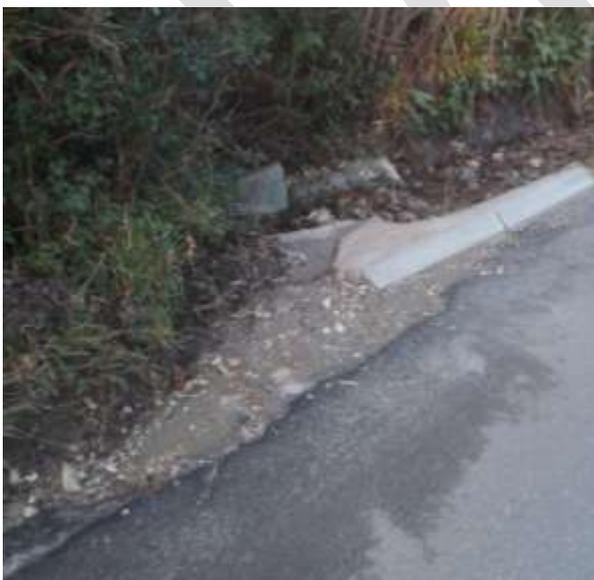
600mm culvert discharging into open ditch at right angles. Downstream channel smaller in capacity than that upstream section. Culvert becomes quickly blocked with large shingle/gravel and floods road.

Issues with stability of upstream riparian banks, previous collapse caused significant flooding to properties within Venlake.

Potential for silt trap to prevent blockage to existing culvert and assessment of culvert and downstream channel for capacity. Potential bank works to upstream to prevent risk of collapse and blockage.

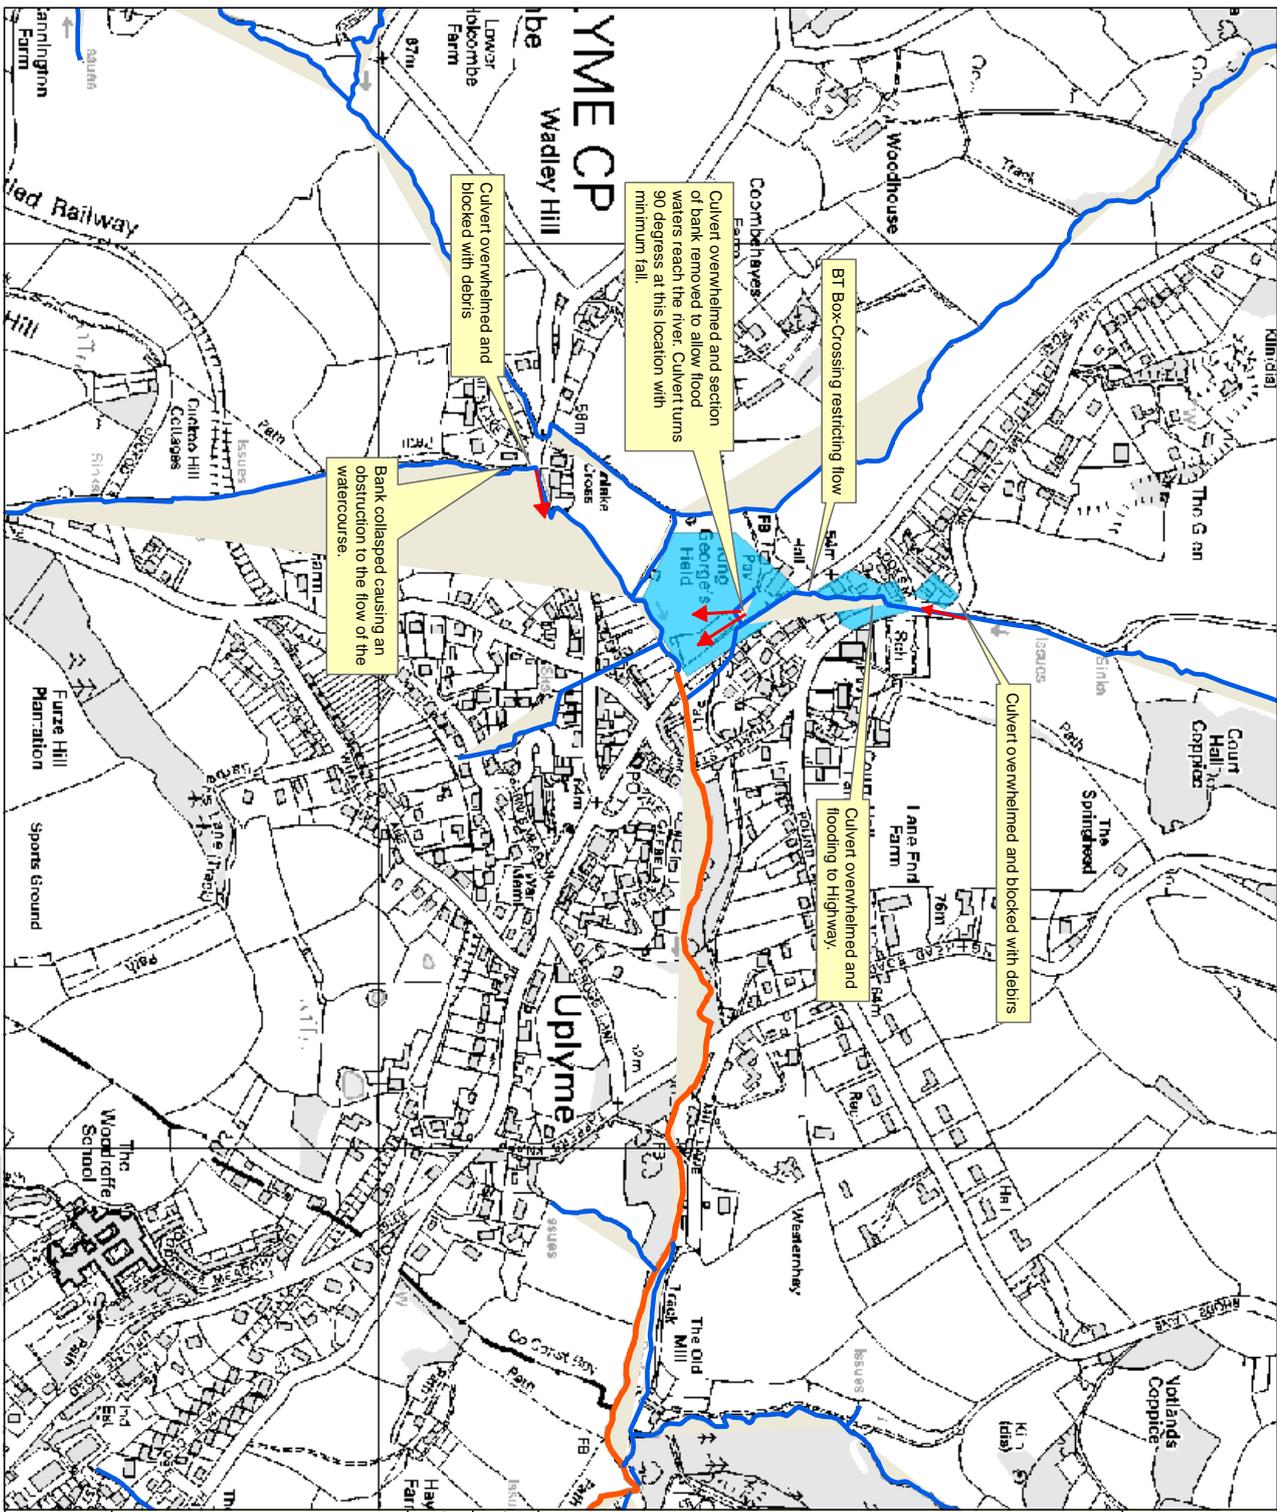
Indicative flooded property outline

This map shows the indicative flood outline and should not be used to identify any individual properties.
